3.14 - Land Subsidence Hazard Profile

The Concept of Land Subsidence

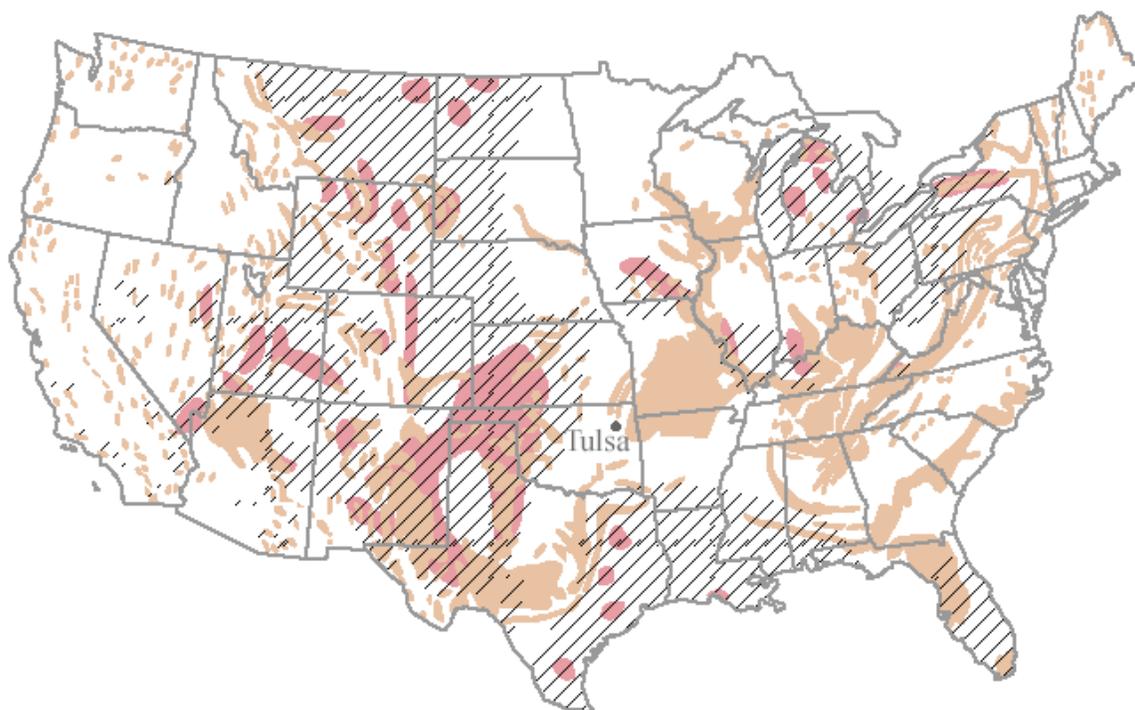
Figure: 3-211

Figure 9. Salt and gypsum underlie about 40 percent of the contiguous United States. Carbonate karst landscapes constitute about 40 percent of the United States east of Tulsa, Oklahoma (White and others, 1995).

Evaporite rocks—salt and gypsum
Karst from evaporite rock
Karst from carbonate rock

Source: USGS Fact Sheet-165-00, December 2000, Land Subsidence in the United States.

It is estimated that land subsidence and resulting flooding and structural damage costs \$125 million annually and an additional \$400 million is spent nationwide in attempts to control subsidence (Prince, U.S. Geological Survey). **Figure 3-211** and **3-212** identify underlying rock and mineral types, some of which lend to the potential of land subsidence. In the absence of a formal land subsidence hazard map, this plan presents information in **Figure 3-211** and **3-212** indicating land subsidence susceptible areas in the State based on the characteristic of underlying rock type.

Figure 3-211 also indicates the existence of evaporate rock (salt and gypsum) from western to central New York. According to NYSGS staff, cavity collapse land subsidence, better known as sink holes, have a tendency to occur more often than not due to man-made influences, (i.e., a mine), and more often in ground that is made up of evaporite rock, which includes salt and gypsum. Evaporative rock (salt and gypsum) are soluble in water and large cavity formations can occur. Sink holes or cavity collapses occur when these underground voids are created naturally, or artificially, and collapse due to natural or human induced forces.

Underlying Rock: As **Figure 3-211** indicates, evaporite rocks (salt and gypsum) underlie about 40 percent of the contiguous United States. (Martinez and others, 1998), and Carbonate Karst landscapes constitute about 40% of the U.S. east of Tulsa, Oklahoma (White and others, 1995). New York State is no exception; in fact it appears that **Figure 3-212** indicates a similar percentage for the State.

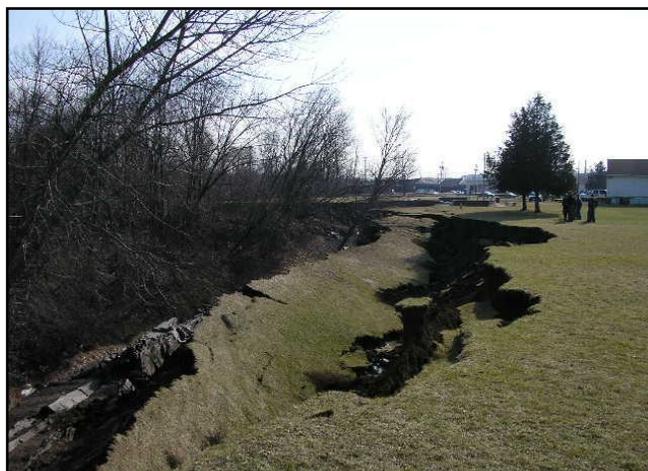
Figure 3-213 Claverack Creek in February 2006

On February 2, 2006, SOEM Region II was notified by the Columbia County Emergency Management Office that an approximately 675-foot section of the bank of Claverack Creek has subsided into the Creek in the area of the Italian American Center in the Town of Greenport. The erosion was estimated to be approximately 30 feet deep. No physical structures were damaged, but a quarter-mile of Bridge Street was closed due to the subsidence.

This never came to pass. Within 24 hours, even though the accident site received over an inch of rain after the collapse, the agencies at the scene declared the situation stable and indicated there was no threat to adjacent properties. Minor damage occurred to recreational facilities and a 20-foot area of a wall collapsed near the Italian American Center. The only flooded area was a farm where the water ponded. The creek has taken a new natural flow and is presently flowing freely. The community has decided to let the creek flow in its new course and remove any trees that are in the way, and the county jail continues to function normally.

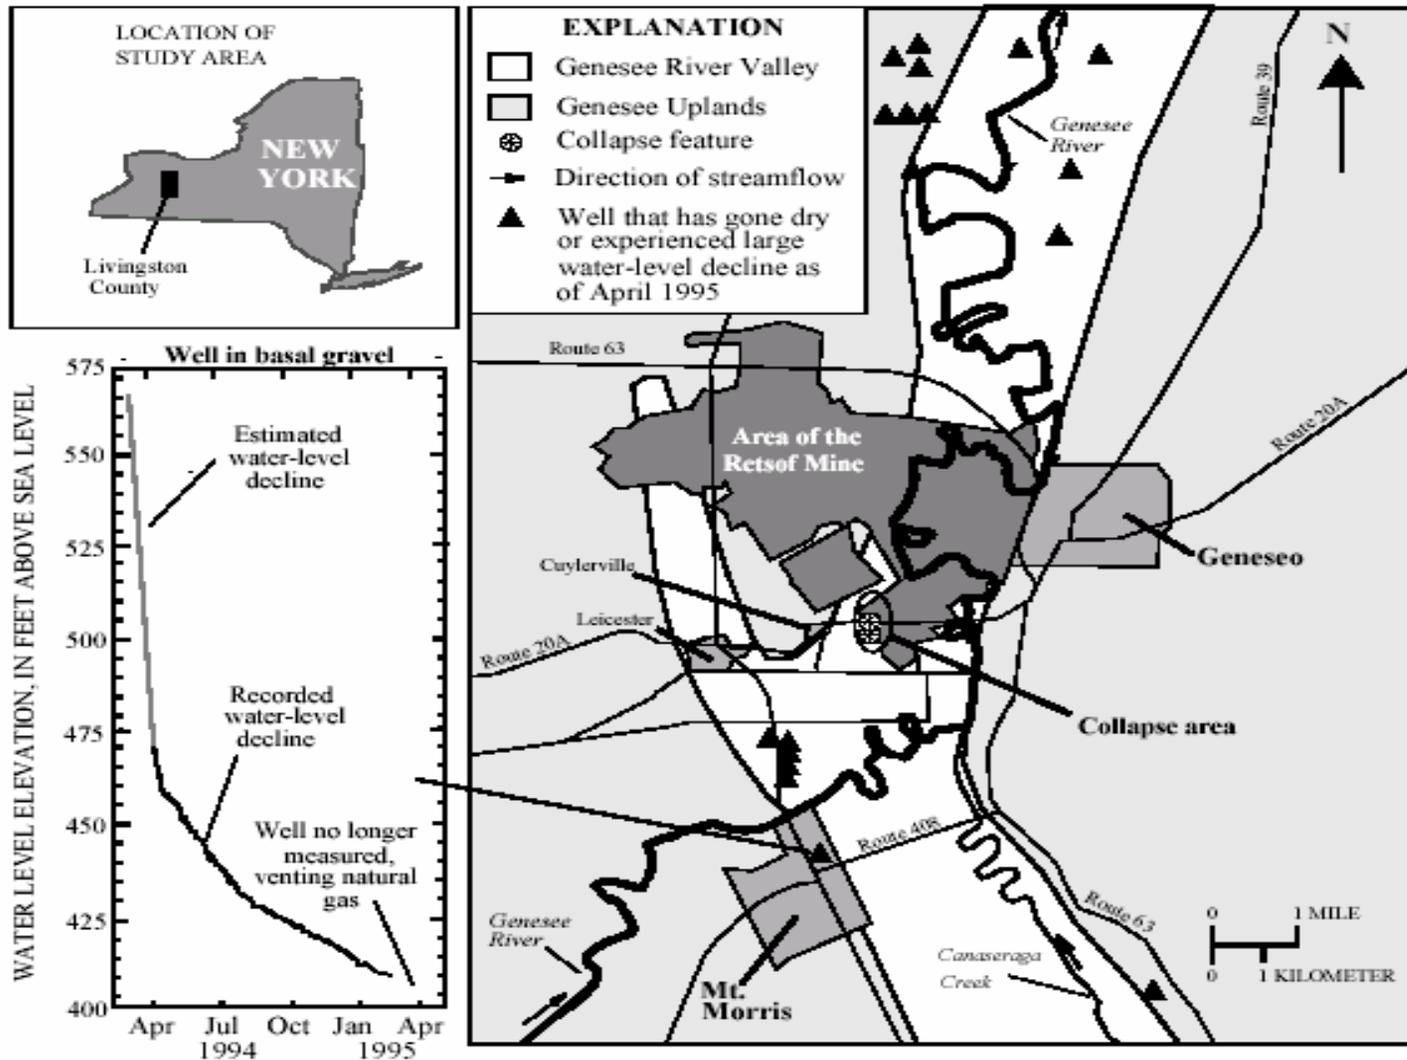
Figure 3-214
 U.S. Geological Survey Open-File Report 97-47

Figure 1. Location of Retsof Salt Mine, area of collapse, and hydrograph of water-level decline in a well 3.5 miles from the mine.

The Retsof Salt Mine is in Livingston County, New York, about 25 mi (40 km) southwest of Rochester (fig. 1). This mine which has been in operation for 110 years and is about 1,100 ft (335 m) below land surface, supplies road salt to 14 states in the Northeast. Retsof Salt Mine is the largest salt mine in the Western Hemisphere and includes an underground area that is roughly the size of Manhattan (6,500 acres or about 2,630 hectares). An underground room at the southern end of the mine near Cuylerville collapsed on March 12, 1994, and an adjacent room collapsed in early April. Two large circular collapse features that are several hundred feet apart have developed at land surface above the two collapsed mine rooms. The northernmost feature, which is about 700 ft (213 m) in diameter, includes a central area about 200 ft (60 m) wide that has subsided about 20 to 30 ft (6 to 9 m). The southernmost feature, which is about 900 ft (274 m) in diameter, includes a central area that is about 700 ft (213 m)

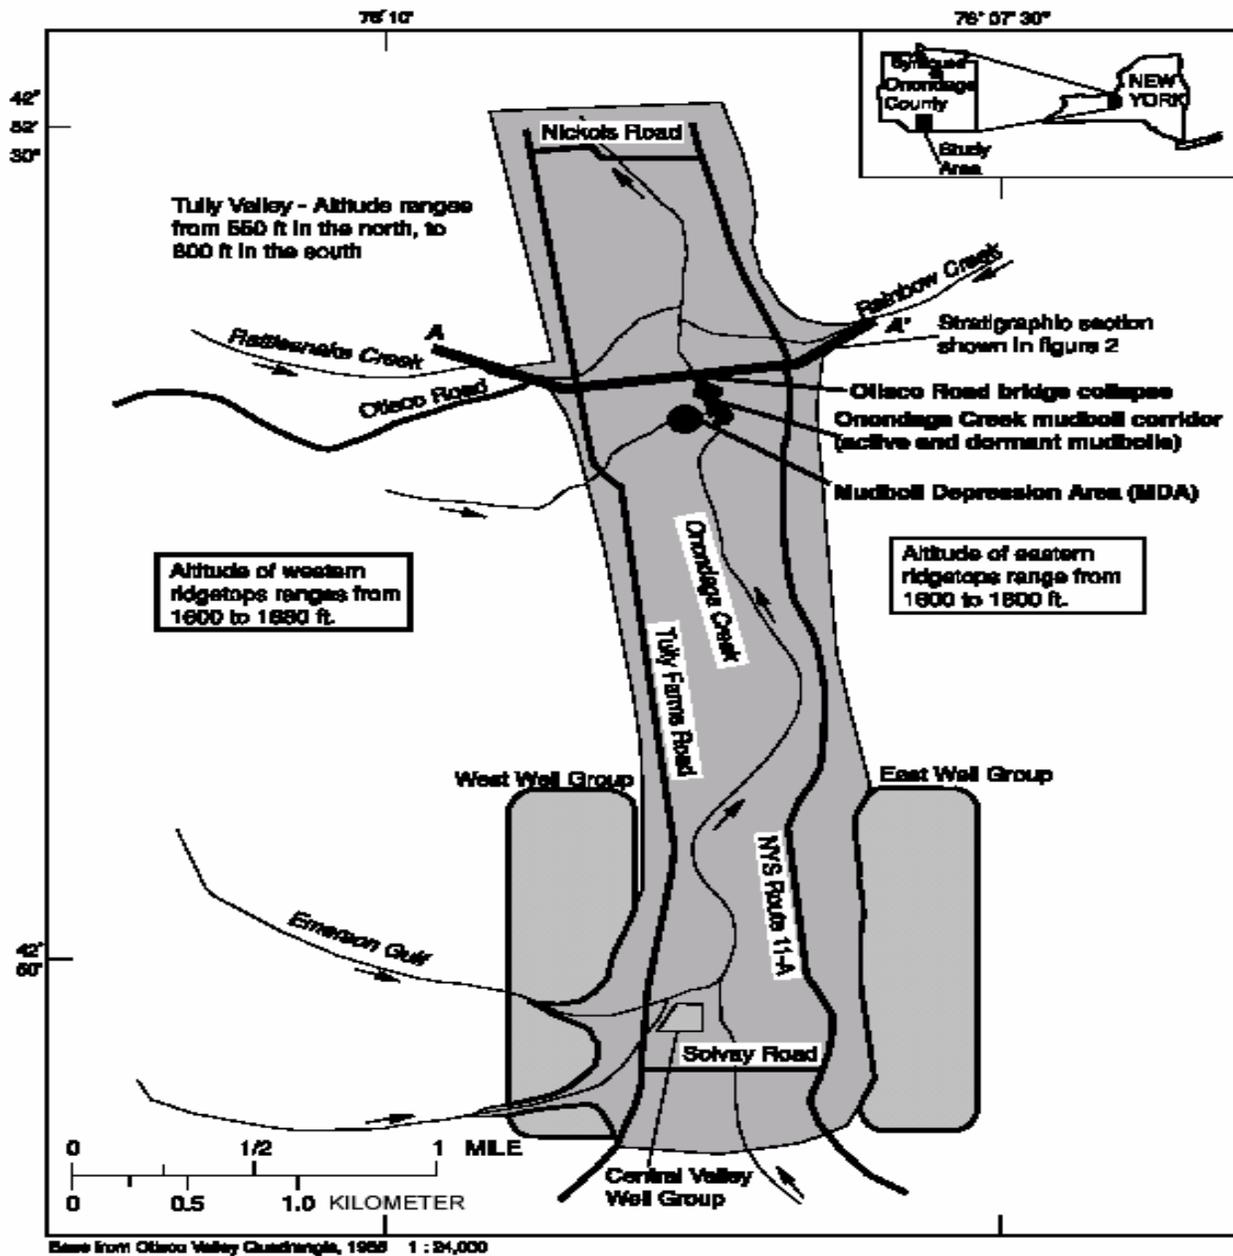
Figure 3-215

Figure 1. Geographic features in the Tully Valley, Onondaga County, New York. Tully Valley is about 20 miles south of Syracuse, New York.

The discharge of turbid ground water and fine sand to the land surface in the Tully Valley, approximately 20 miles south of Syracuse, New York, has formed a series of mudboils (fig. 1). The volcano-like cone of a mudboil can be several inches to several feet high and from 1 ft to more than 30 ft. in diameter. Where mudboil activity is persistent, the removal of sediment at depth has caused land subsidence. Depending on the depth of the source zone, individual mudboils discharge fresh or brackish ground water. The temperature of freshwater discharges ranges between 45 and 55 degrees Fahrenheit; the temperature of brackish water discharge is nearly constant at 51 degrees Fahrenheit. Mudboil activity may be natural or may be associated with a large solution salt-mining operation that began in the southern part of the valley in the late 1800's and ceased in 1988. The mined salt beds range from 1,000 to 1,400 ft below land surface (fig. 2). The northern extent of the brining operation is one (1) mile south of the mudboil area; the northern limit of its effect is unknown. Dissolution of the salt beds initially utilized injected surface water but since the late 1950's dissolution has occurred only under natural conditions, involving ground-water infiltration to the salt beds from the surrounding fractured bedrock and possibly from the more permeable unconsolidated glacial deposits in the Tully Valley.

The earliest known mudboil in Tully Valley, reported in the Syracuse Post Standard on October 19, 1899, was apparently localized and short-lived. From 1899 to the 1970's, the mudboils within the Onondaga Creek mudboil corridor (fig. 1) appeared and dissipated over a span of several weeks to a few months but had no long-term effect on the water quality of Onondaga Creek and Onondaga Lake, 20 mi downstream. Active mudboils became increasingly persistent during the mid-1970's, causing turbid discharges that degraded the quality of Onondaga Creek. Before the mid-1980's, relatively fresh ground water was discharged from what is now called the main 'mudboil depression area' (MDA), located 1,500 ft south of Otisco Road (fig. 1). Since then, however, the discharge has been more brackish, and land subsidence (locally as much as 15 ft.) has progressed outward. In June 1991, a new mudboil appeared in Onondaga Creek just upstream of the Otisco Road Bridge (fig. 1), and within 2 months the bridge collapsed. Subsidence around the 150-ft radius of this collapse area ranges from several inches at the perimeter to more than 5 ft. at the bridge.
